The Rail Safety
Inspection Office

NIB ANNUAL REPORT 2015

according to Article 23(3) of Directive 2004/49/EC

September 2016

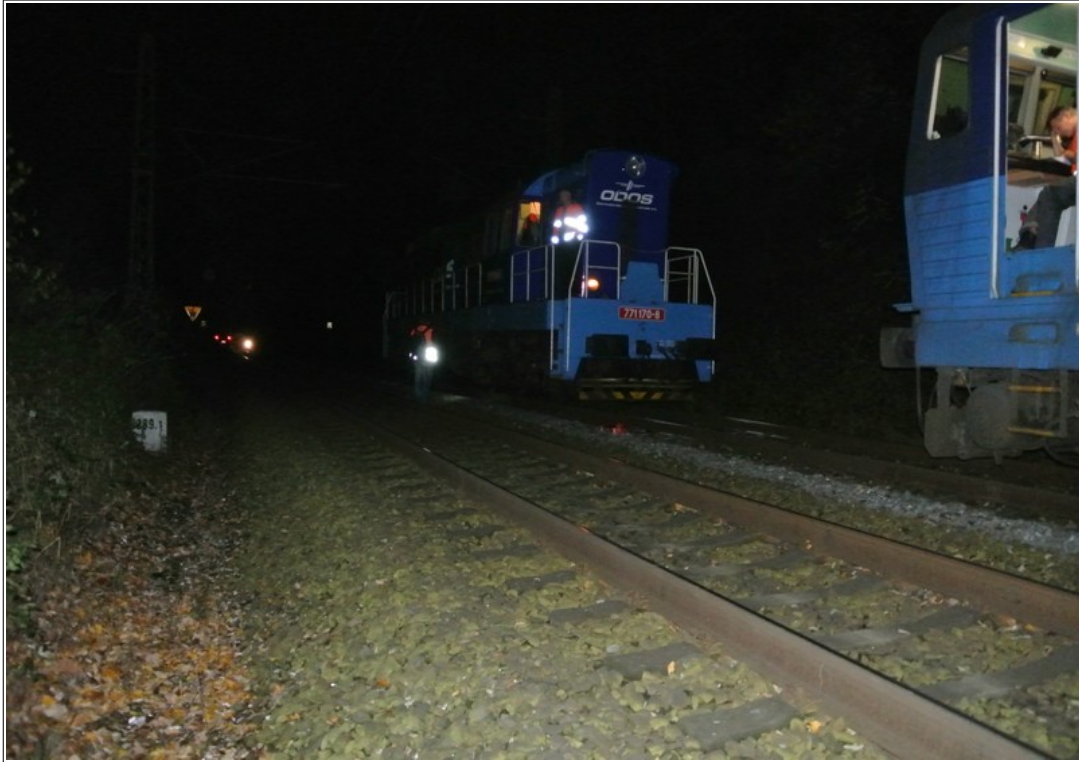
Grade:	accident.
Date and time:	16 th November 2014, 6:48 (5:48 GMT).
Occurrence type:	overhead contact line and collector collision.
Description:	overhead contact line damage caused by collector of fast passenger train No. 803 locomotive and consequent bumping into damaged overhead contact line by shunting operation.
Type of train:	long distance passenger train No. 803.
Location:	Hrušovany u Brna station, track No. 1, km 125,150 (Lanžhot st. hranice – Brno hl. n. main line).
Parties:	SŽDC, s. o. (IM); ČD, a. s. (RU of the long distance passenger train No. 803).
Consequences:	0 fatality, 0 injury; total damage CZK 310 075,-
Direct cause:	indeterminate and sudden damage of locomotive collector.
Contributory factor:	none.
Underlying cause:	none.
Root cause:	none.
Recommendations:
