The Rail Safety
Inspection Office

NIB ANNUAL REPORT 2015

according to Article 23(3) of Directive 2004/49/EC

September 2016

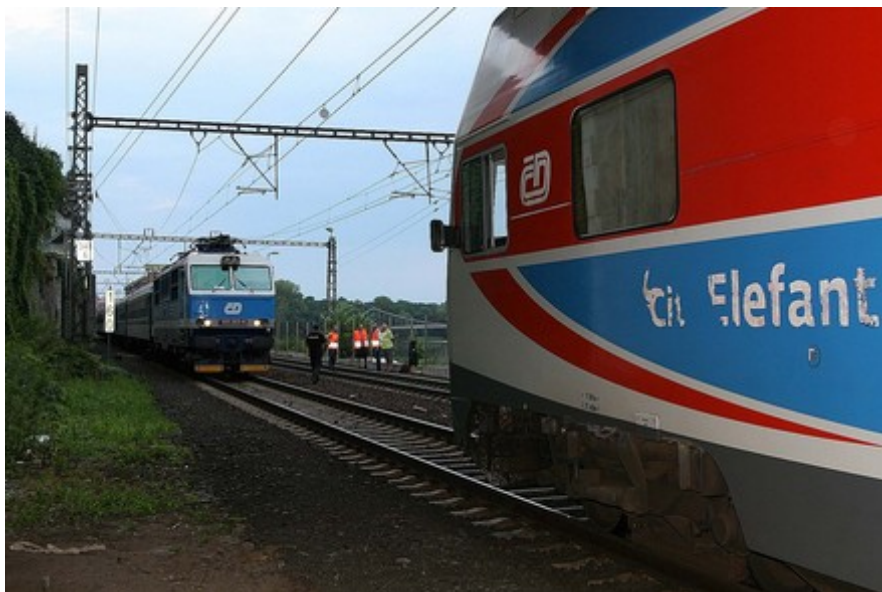
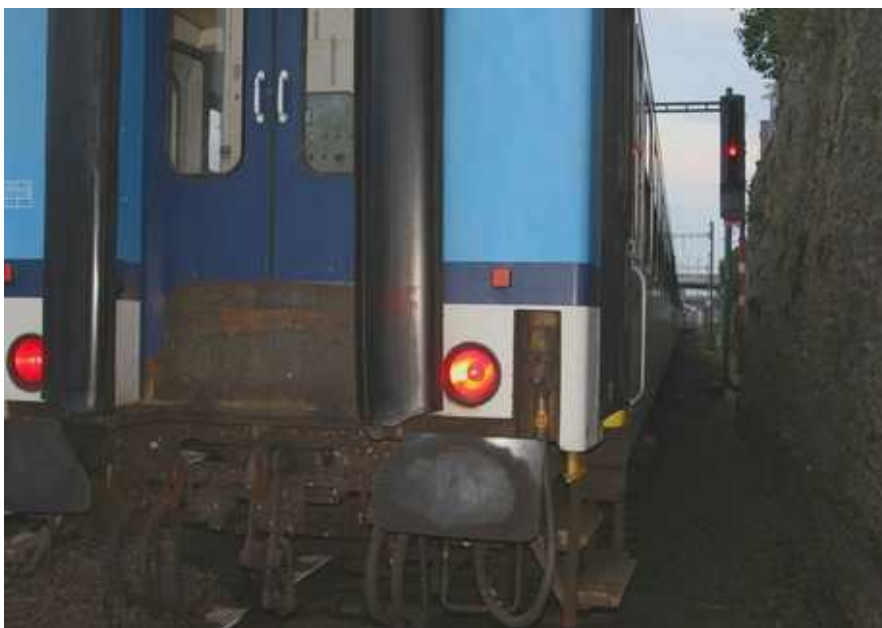
The goal of this safety recommendation is to increase the focus on avoiding situations of potential danger to rail paths of rolling stocks (two trains, shunting against each other). Eventually emergency stop these trains, whose safety are threatened, automatically in case of unauthorized movement behind the main signal.

- it is recommended to adopt own measure forcing implementation of the above recommendations for other infrastructure managers (IM) and railway undertakers (RU) in the Czech Republic. Because the rail operation and rail transport safety is based on close cooperation between RUs and Ims.

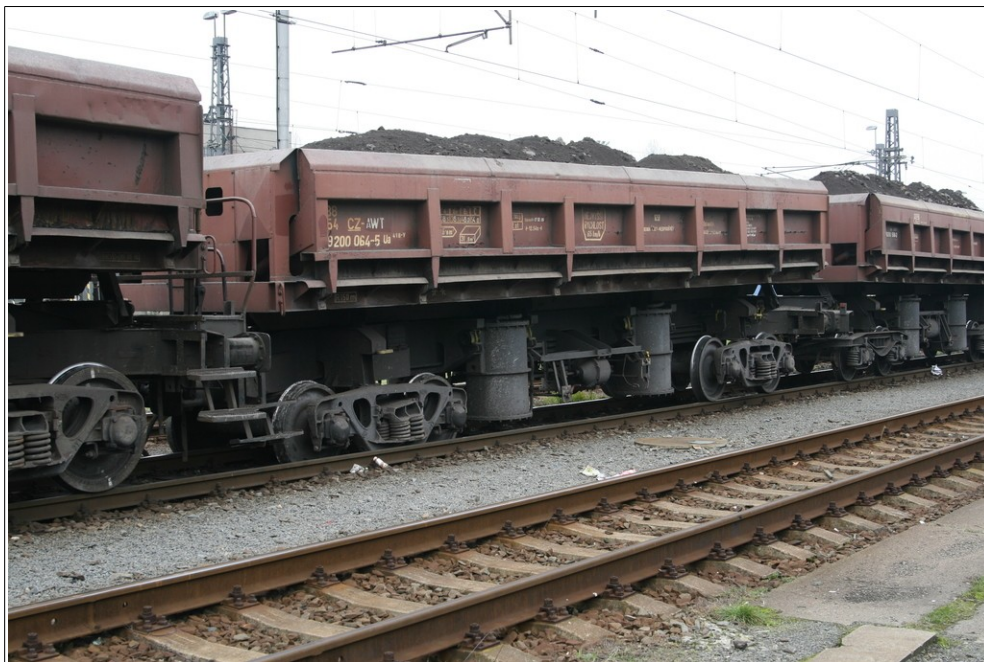
Goal of the safety recommendation is to ensure that a valid certificate of IM correspond to reality and requirements of the SMS.

- it is recommended to take own measure forcing implementation of the above recommendation for all other IMs within Czech republic, or more precisely measures in the process of publishing, respectively changing of safety certification of IM in terms of completeness and accuracy of the SMS.

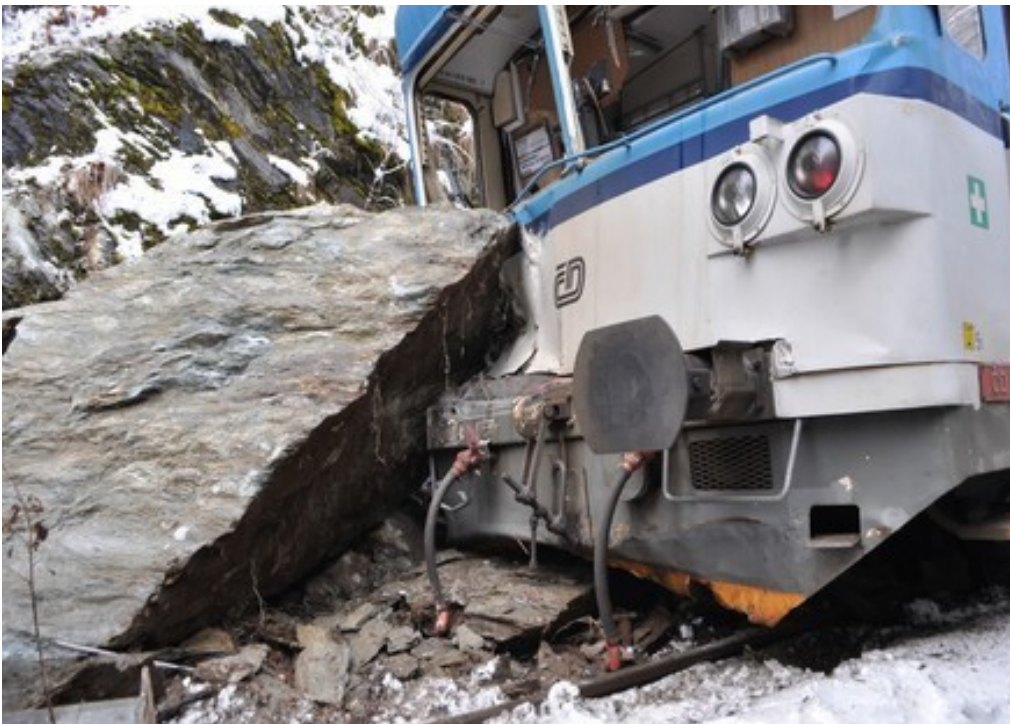
technical threats, which are endangering railway safety. It is needed to introduce a kind of system, for keeping the state of the rock faces under control. The state of these rock faces is needed to be regularly checked and the measures to prevent potential threats need to be taken soon enough.

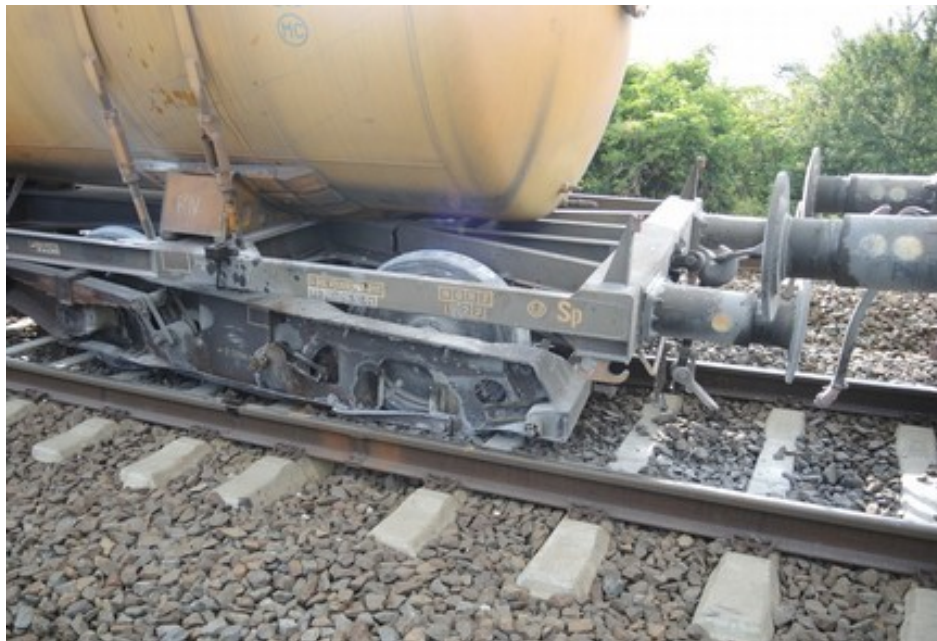
The goal of issued recommendations is preventing accidents/incidents caused by inadequate technical state of wagons, when one or more wagons are derailed, but without the common related effect – air leakage from the brake pipe and consequent automatic initiating braking performance. The train continues without even noticing it. Noticeable factor, that supports equipping wagons with pneumatic derailment detectors is the IM's attitude, who cut down numbers of stations with crew responsible to check the trains and able to recognize rail vehicle defects. The result is increase of the numbers or length of segments in which the trains are not monitored.

- to take own measure towards holder of the derailment freight wagon (CTL KOLZAP Sp. z o. o.), in order to force them to take care about their towed rolling stocks, especially about towed rolling stocks with installed axles produced in ironworks 1 Maja Gliwice in 1986 and earlier, so that the freight wagons will meet the requirements throughout their use for the operation of railway transport.
