**The Rail Safety  
Inspection Office**

# **NIB ANNUAL REPORT 2019**

according to Article 23(3) of Directive 2004/49/EC

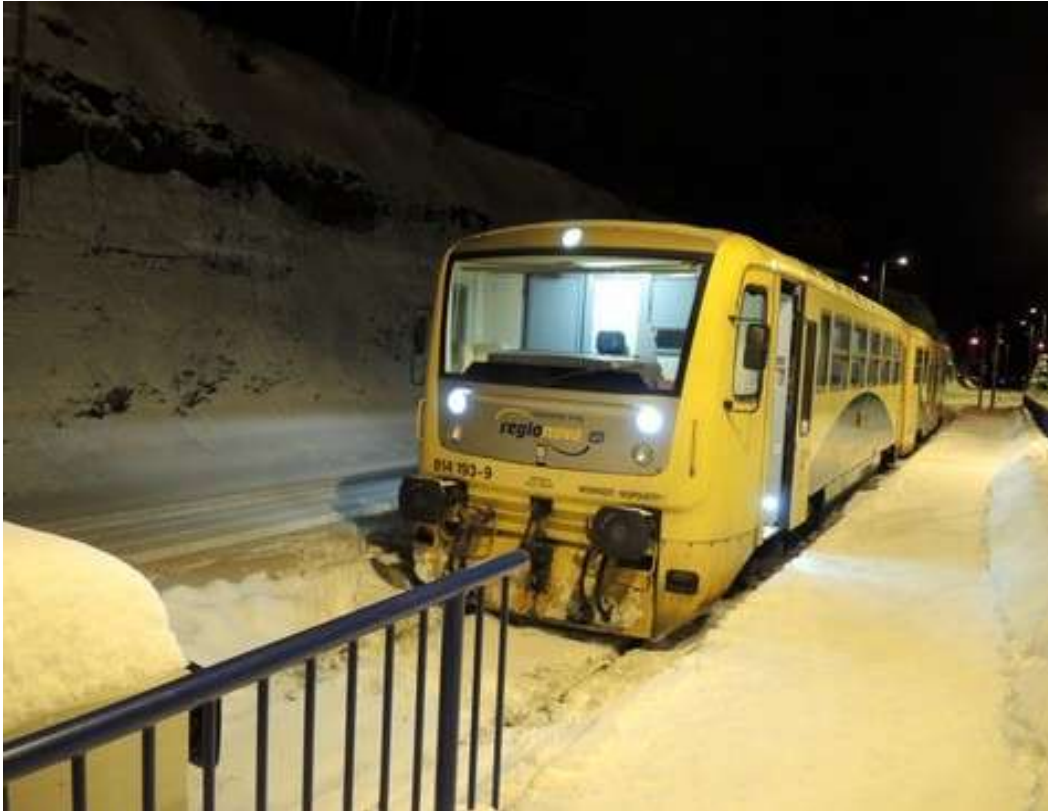
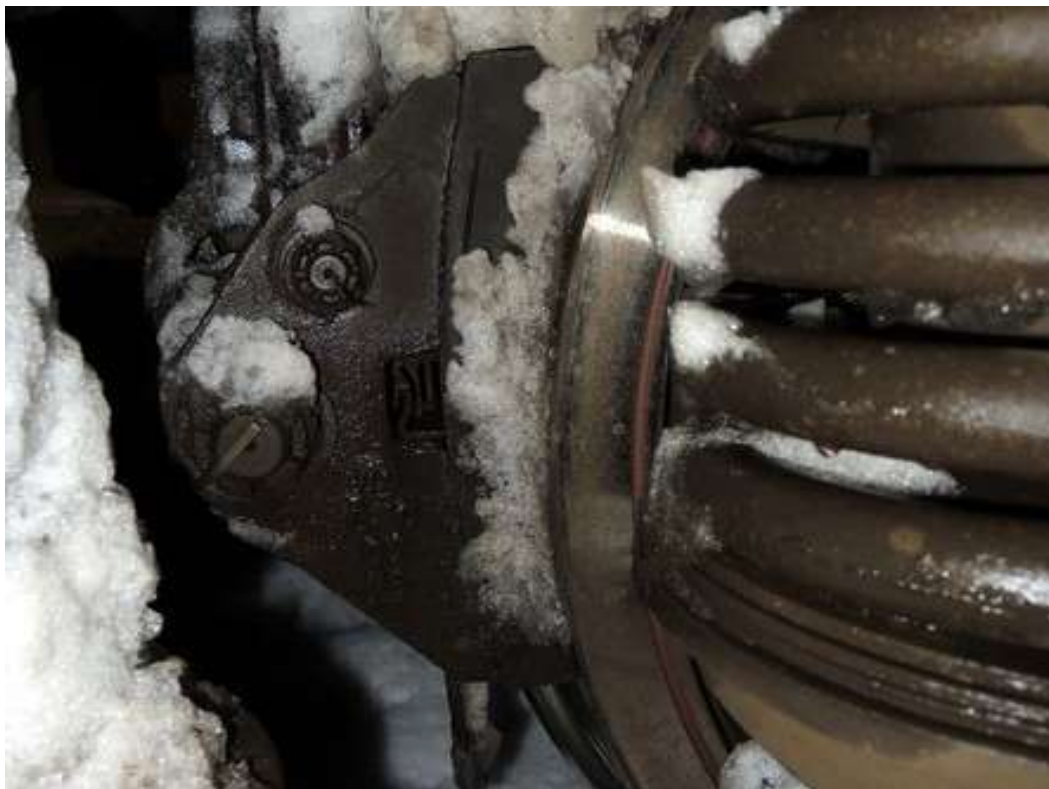
Grade: an accident.  
Date and time: 3<sup>rd</sup> February 2018, 8:35 (7:35 GMT).  
Occurrence type: a train collision.  
Description: the unsecured movement of the shunting operation with the consequent collision with the standing locomotive.  
Type of train: the shunting operation.  
Location: Mělník station, the shunting district No. 2, km 372,189; a place of the collision: the station track No. 12, km 372,132.  
Parties: SŽDC, s. o. (IM);  
ČD Cargo, a. s. (RU of the shunting operation).  
Consequences: 3 injuries;  
total damage CZK 3 416 620,-

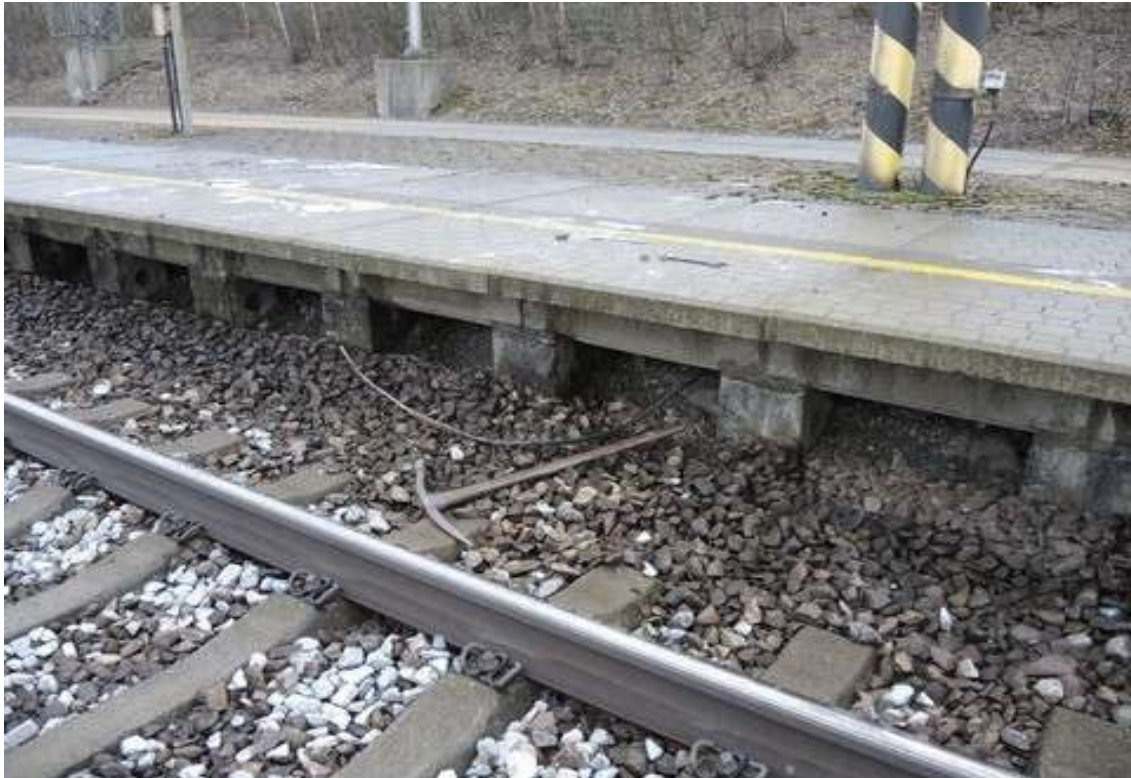
- Grade: an incident.
- Date and time: 29<sup>th</sup> April 2018, 17:32 (15:32 GMT).
- Occurrence type: a train derailment.
- Description: an unsecured ride with the consequent derailment of the regional passenger train No. 8532 at the switch No. 1sv, which was not correctly switched in the preferred position.

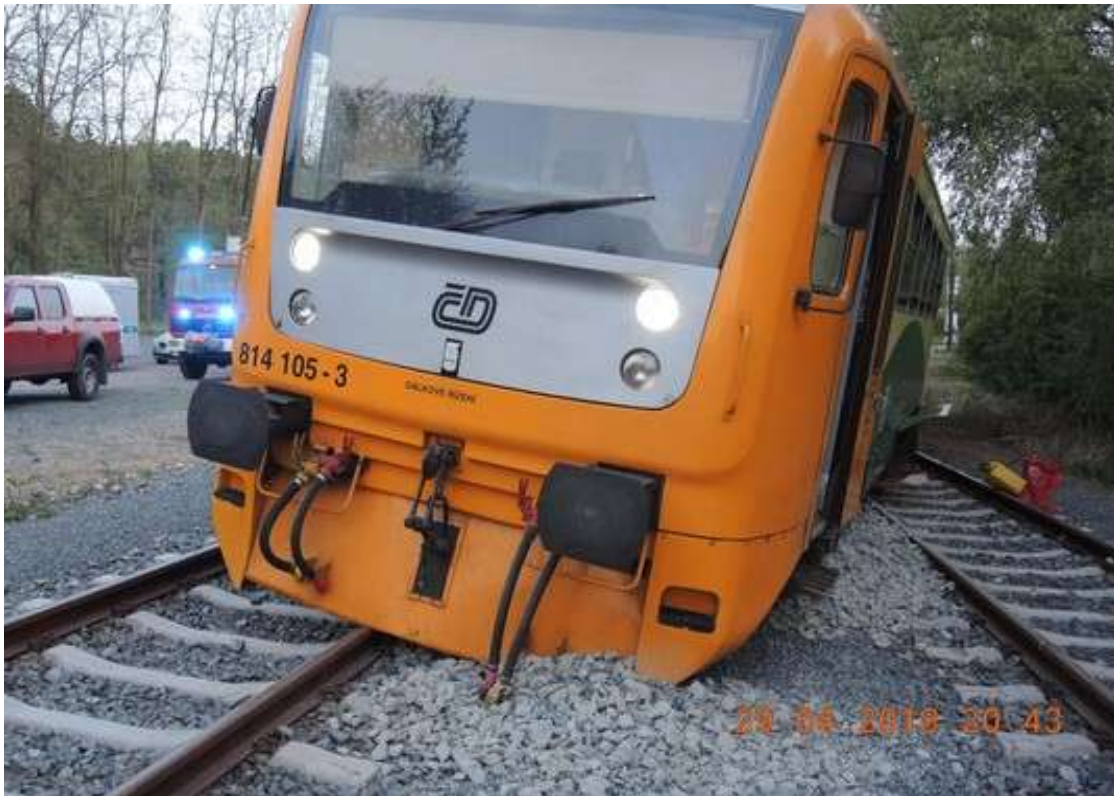
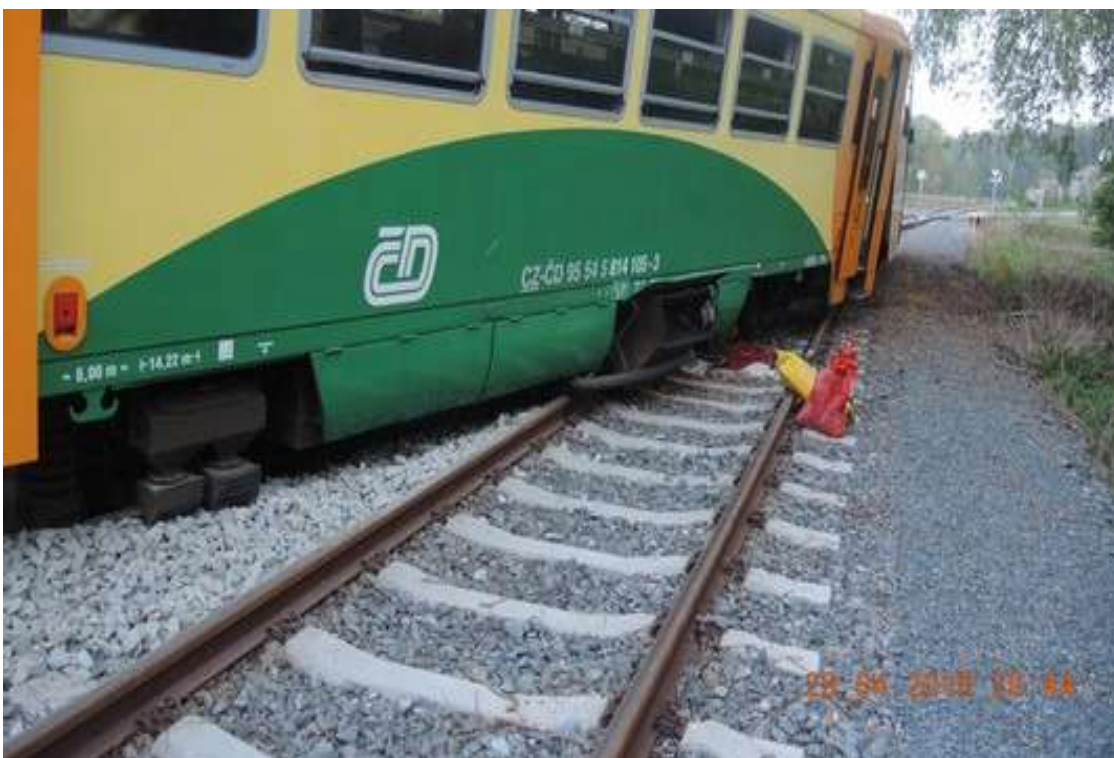
Grade: serious accident.

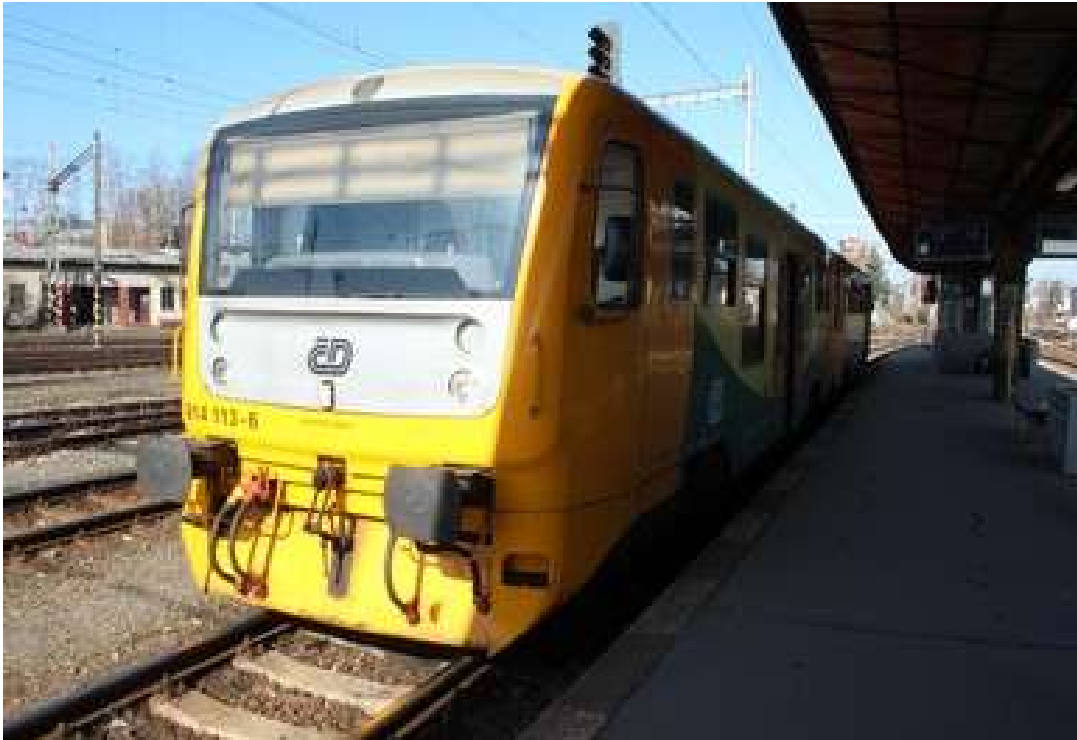
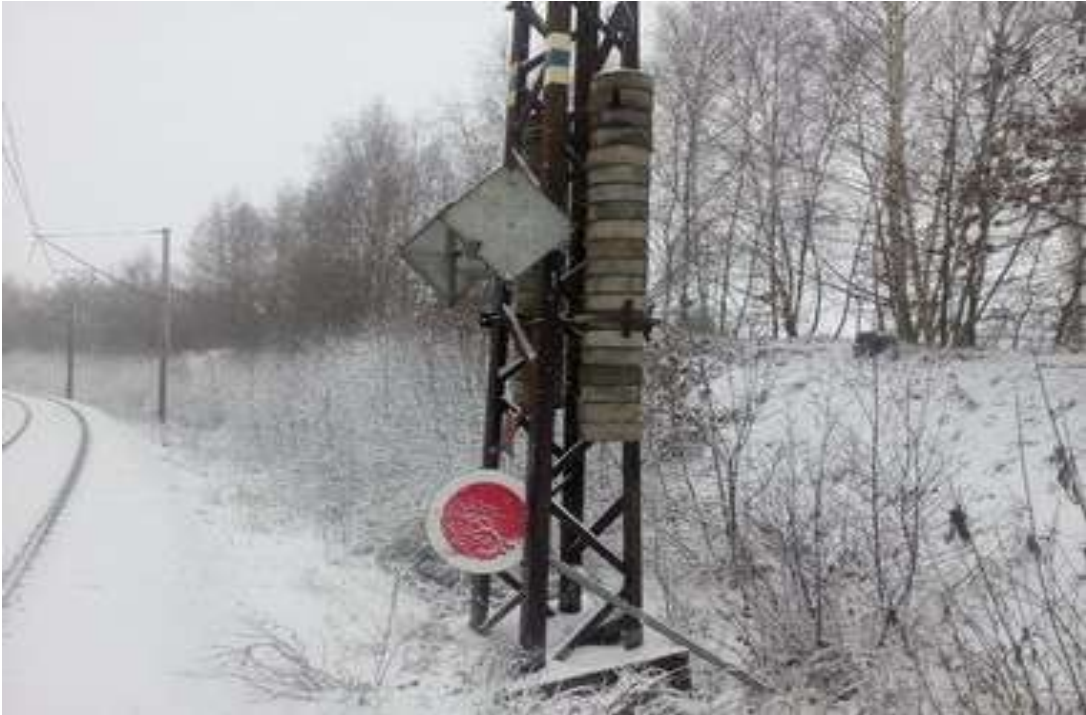
Grade:	incident.
Date and time:	10 <sup>th</sup> January 2019, 6:34 (5:34 GMT).
Occurrence type:	collision of the train with the railway technical device (buffer stop).
Description:	unauthorized movement of the regional passenger train No. 1997 behind the main (route) signal device Lc 102, consequent collision with a buffer stop, derailment and collision with an equipment of the station.
Type of train:	regional passenger train No. 1997.
Location:	Liberec station, station track No. 102, main (route) signal device Lc102, km 160,256; place of the collision with the buffer stop – at the end of the station track No. 102, km 160,264 <sup>5</sup> .
Parties:	SŽDC, s. o. (IM); ČD, a. s. (RU of the regional passenger train No. 1997).
Consequences:	0 fatality, 0 injury; total damage CZK 553 761,-
Direct cause:	<ul style="list-style-type: none"><li>• failure to respect the signal „Stop“ of the main (route) signal device Lc102 at Liberec station by the train driver of the regional passenger train No. 1997.</li></ul>

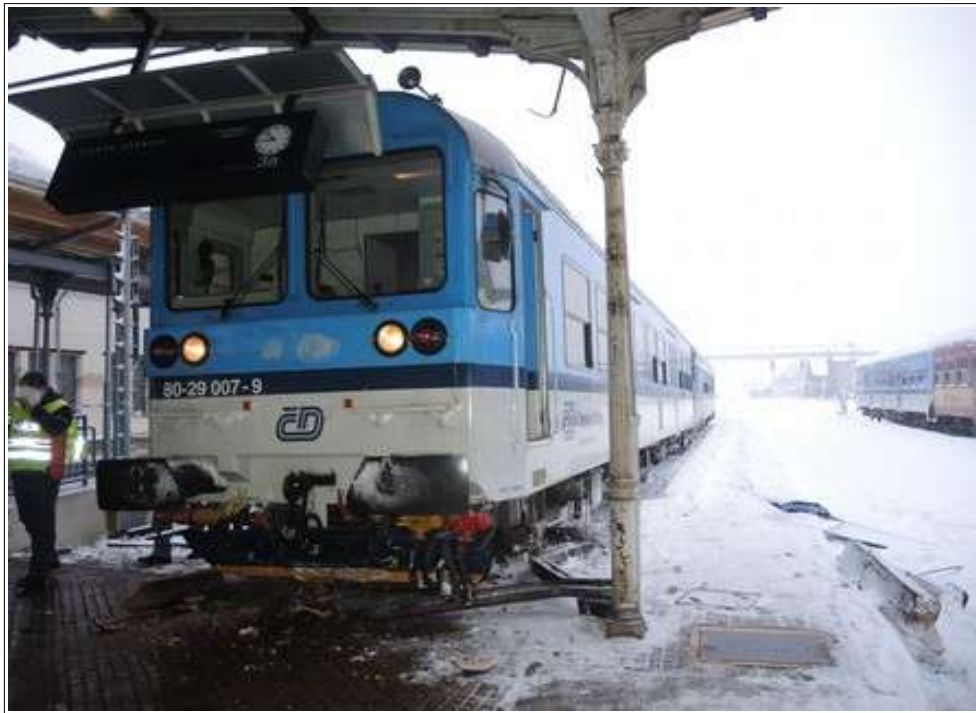
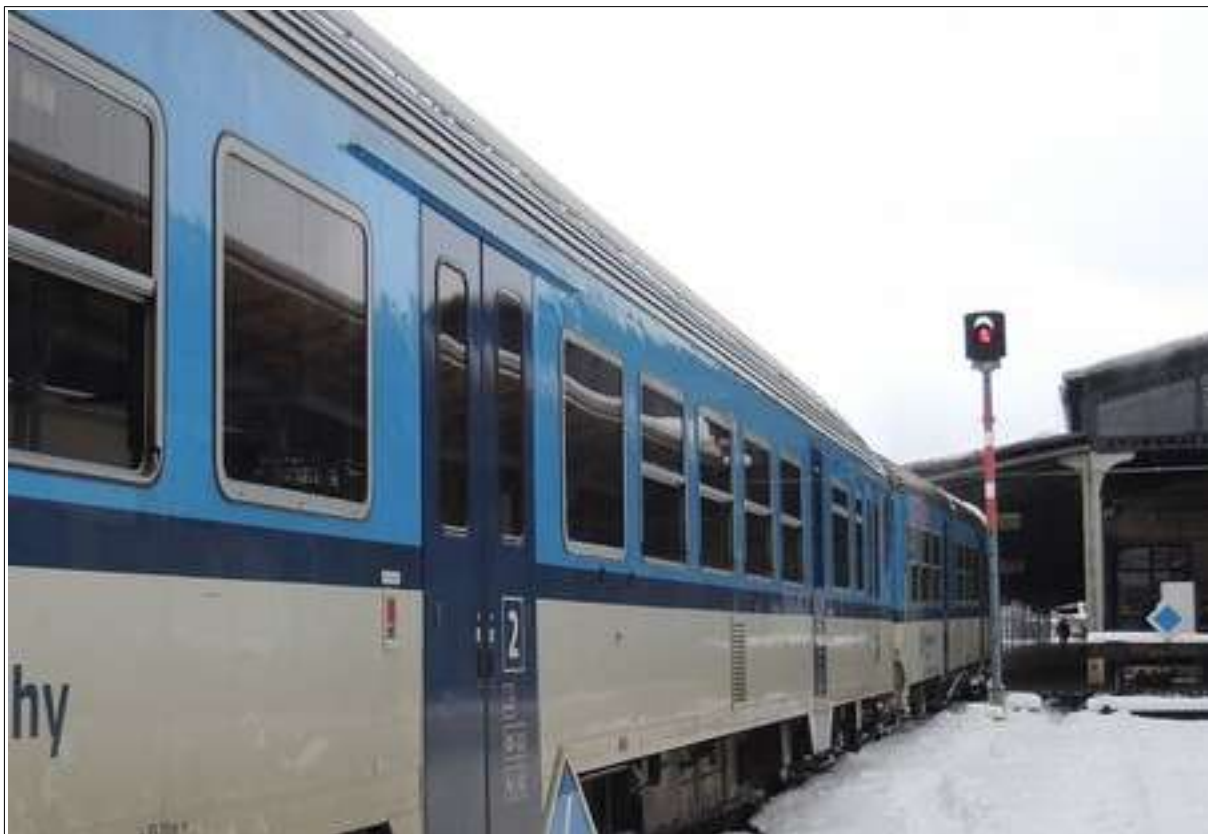
Grade:	incident.
Date and time:	18 <sup>th</sup> January 2019, 13:49 (12:49 GMT).
Occurrence type:	uncontrolled movement.
Description:	uncontrolled movement of two detached rolling stocks.
Type of train:	two detached rolling stocks.
Location:	Chodov station, km 21,420 – place of beginning uncontrolled movement; open line between Chodov and Karlovy Vary stations, km 188,828 – place where the rolling stocks stopped (it was 7.177 kilometers from beginning uncontrolled movement).
Parties:	SŽDC, s. o. (IM); ČD Cargo, a. s. (RU of the detached rolling stocks).
Consequences:	0 fatality, 0 injury; total damage CZK 34 743,-
Direct cause:	<ul style="list-style-type: none"><li>insufficient securing of detached rolling stocks against uncontrolled movement.</li></ul>
Contributory factor:	none.
Underlying cause:	<ul style="list-style-type: none"><li>failure to comply of the technological procedures of the IM and RU during detaching of the rolling stocks.</li></ul>

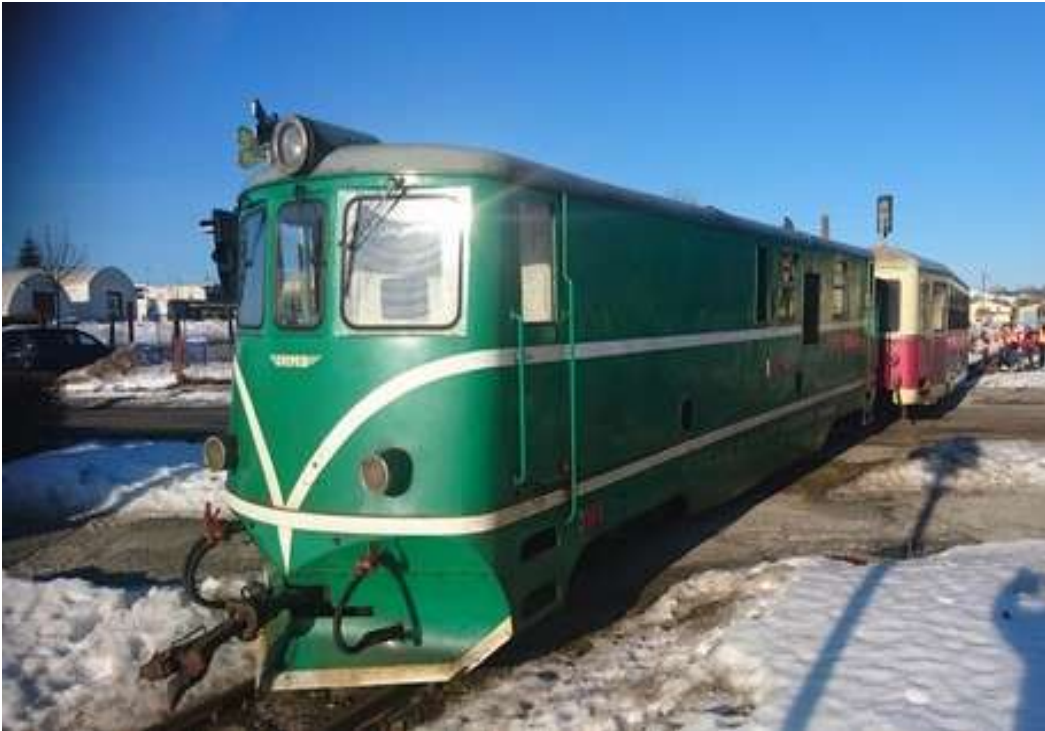
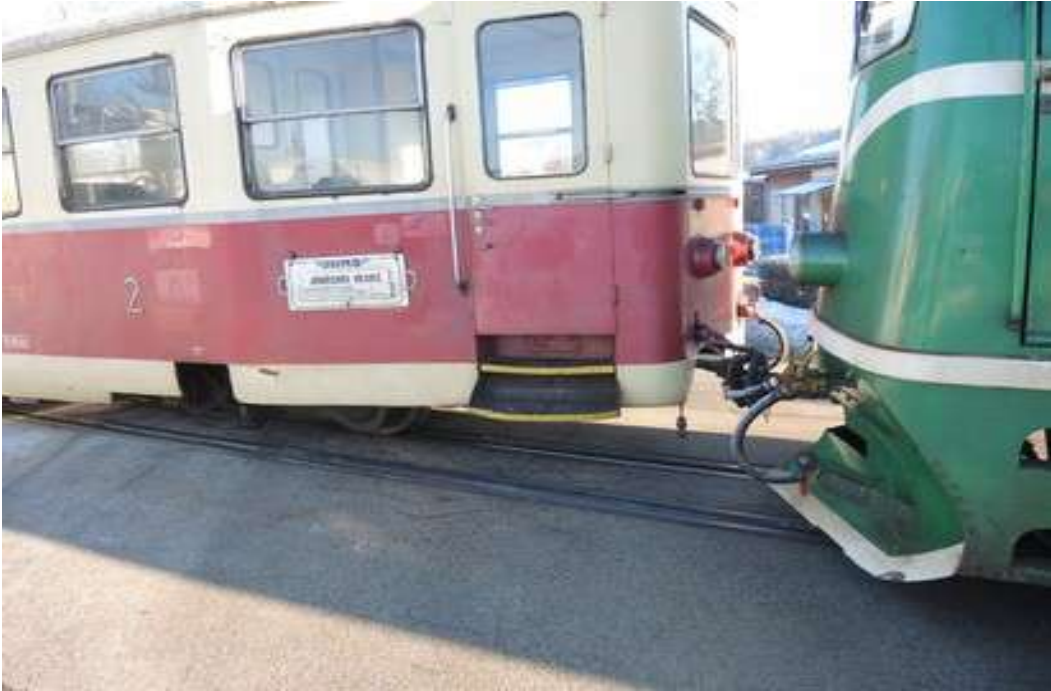
Grade:	incident.
Date and time:	15 <sup>th</sup> February 2019, 4:49 (3:49 GMT).
Occurrence type:	train derailment.
Description:	derailment of one rolling stock of the regional passenger train No. 21221.
Type of train:	the regional passenger train No. 21221.
Location:	Kamenice nad Lipou operating control point, switch No. 2, km 20,244.
Parties:	Jindřichohradecké místní dráhy, a. s. (IM and RU of the regional passenger train No. 21221).
Consequences:	0 fatality, 0 injury; total damage CZK 53 809,-
Direct cause:	<ul style="list-style-type: none"><li>• not remove of device for securing the rolling stock against uncontrolled movement – the rail skate from the rail before the movement of the rolling stocks of the regional passenger train No. 21221.</li></ul>
Contributory factor:	none.
Underlying cause:	<ul style="list-style-type: none"><li>• failure to technological procedures of the IM and RU.</li></ul>

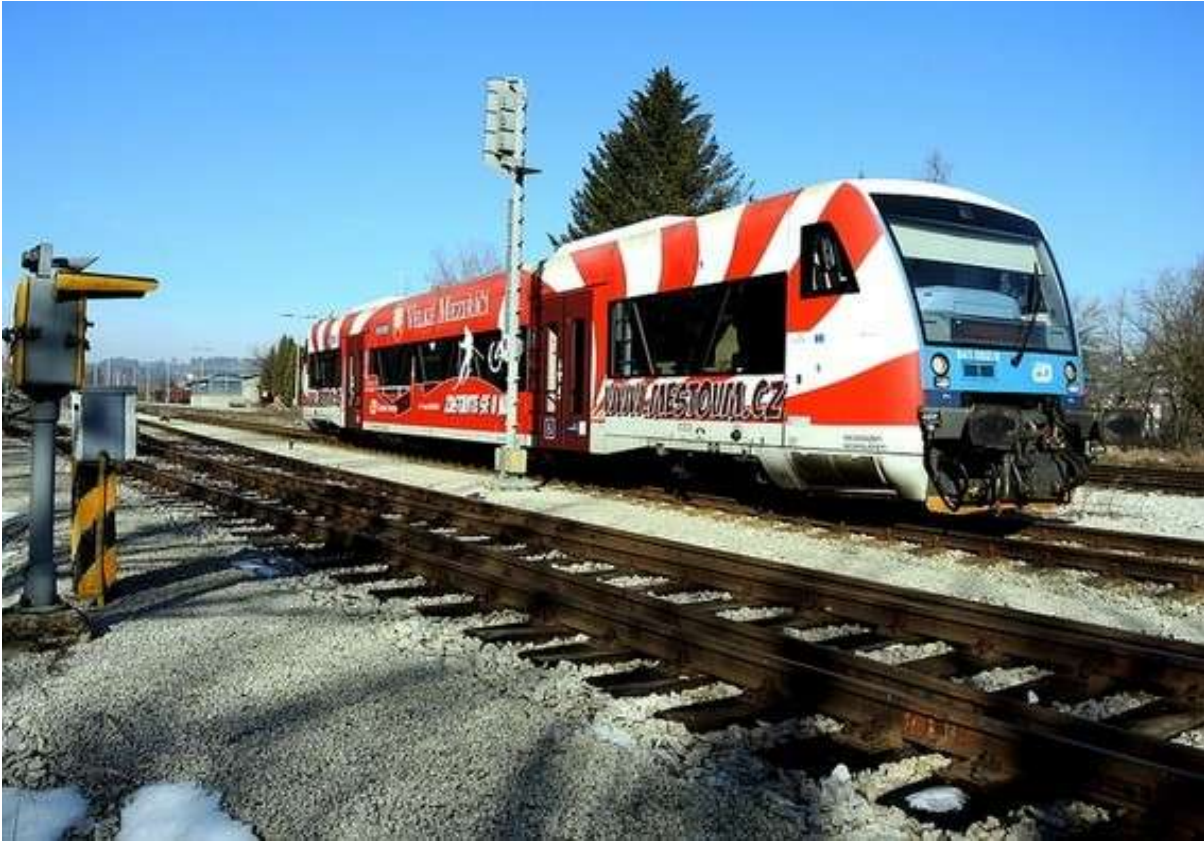
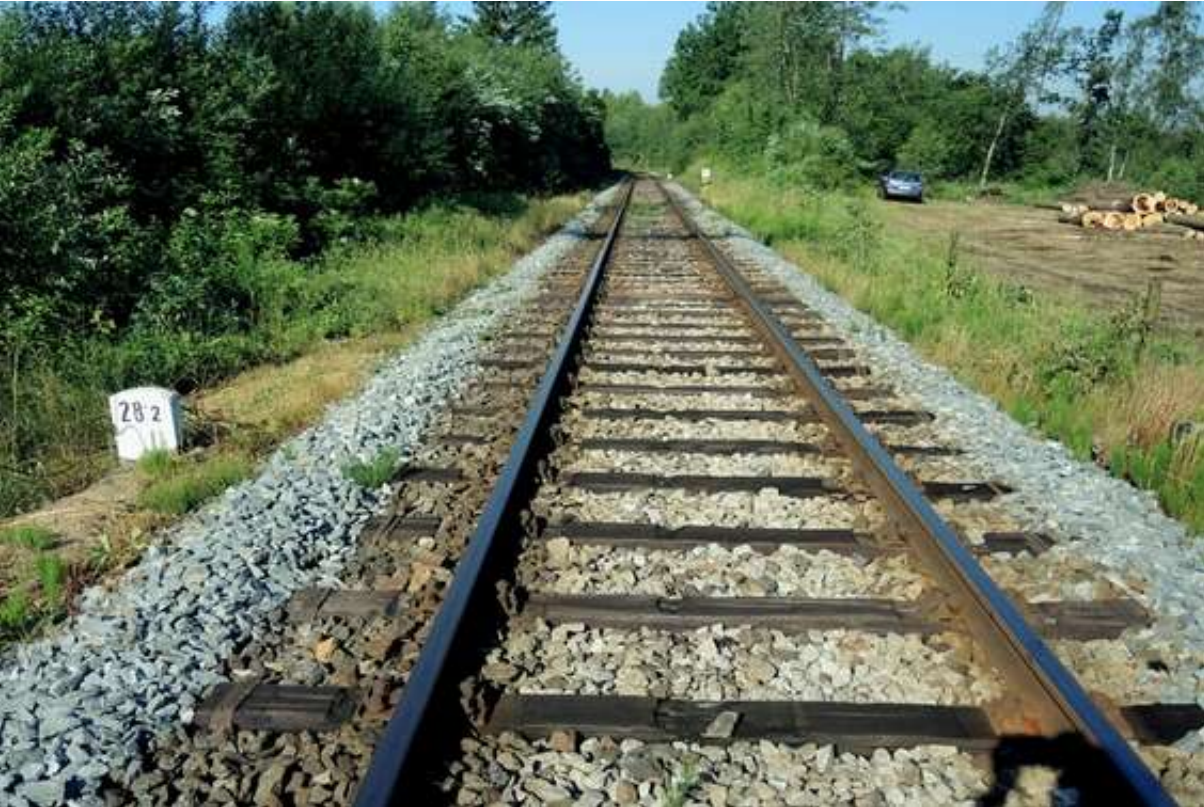
Grade:	an incident.
Date and time:	19 <sup>th</sup> February 2019, 9:13 (8:13 GMT).
Occurrence type:	an unsecured movement.
Description:	the unsecured movement of the regional passenger train No. 24948 without the train driver.
Type of train:	the regional passenger train No. 24948.
Location:	an open line between Velké Meziříčí and Křižanov stations, km 28,196.
Parties:	SŽDC, s. o. (IM); ČD, a. s. (RU of the regional passenger train No. 24948).
Consequences:	0 fatality, 0 injury; total damage CZK 0,-
Direct cause:	<ul style="list-style-type: none"><li>improper handling with the air valves of the brake system while removal of defect of the accumulator switching brake.</li></ul>
Contributory factor:	none.
Underlying cause:	<ul style="list-style-type: none"><li>failure to observe the technological procedures by the train driver of the regional passenger train No. 24948 when removing the defect of the accumulator switching brake.</li></ul>

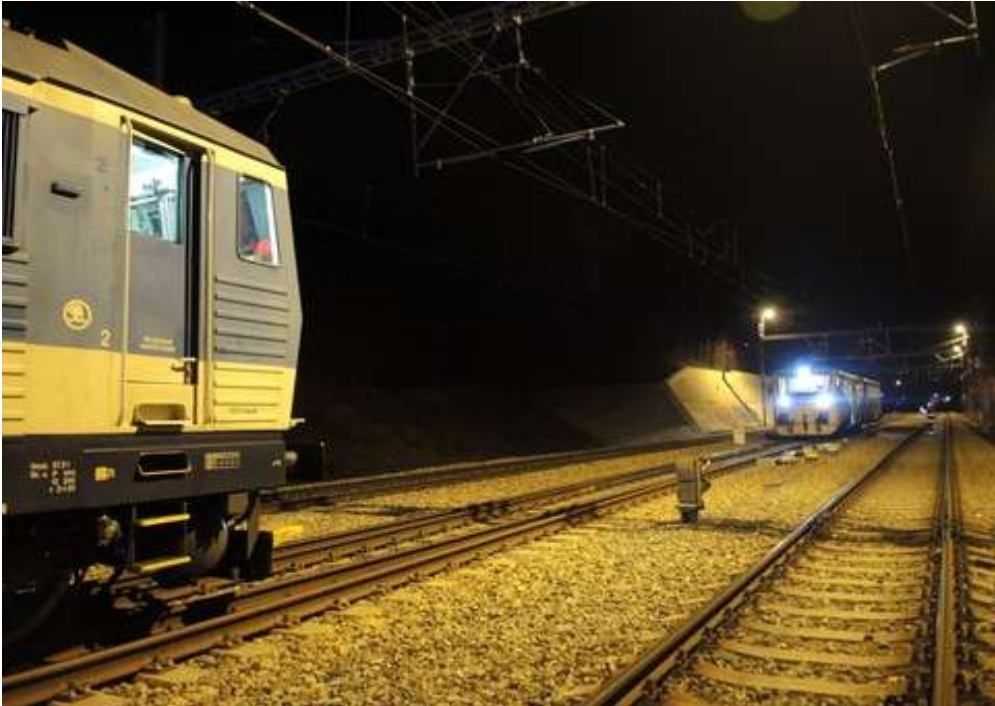
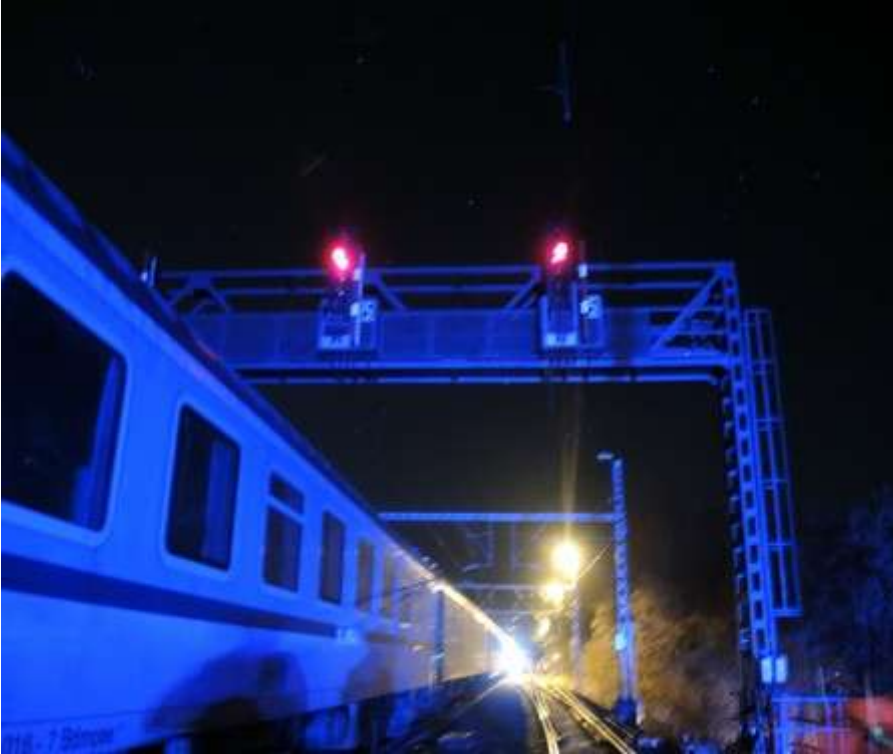
Grade:	an incident.
Date and time:	22 <sup>nd</sup> February 2019, 19:20 (18:20 GMT).
Occurrence type:	an unauthorized movement.
Description:	the unauthorized movement of the long distance passenger train No. 350 behind the main departure signal device L2 and its ride into the train route of the regional passenger train No. 17816.
Type of train:	the long distance passenger train No. 350; the regional passenger train 17816.
Location:	Ejpvovice station, the station track No. 2, the main departure signal device L2, km 93,768.
Parties:	SŽDC, s. o. (IM); ČD, a. s. (RU of the trains No. 350 and 17816).
Consequences:	0 fatalities, 0 injuries; total damage CZK 0.
Direct cause:	<ul style="list-style-type: none"><li>• a departure of the long distance passenger train No. 350 without regular dispatching of the train.</li></ul>
Contributory factor:	<ul style="list-style-type: none"><li>• an absence of the technical equipment which prevents a train from passing a signal in case of danger.</li></ul>

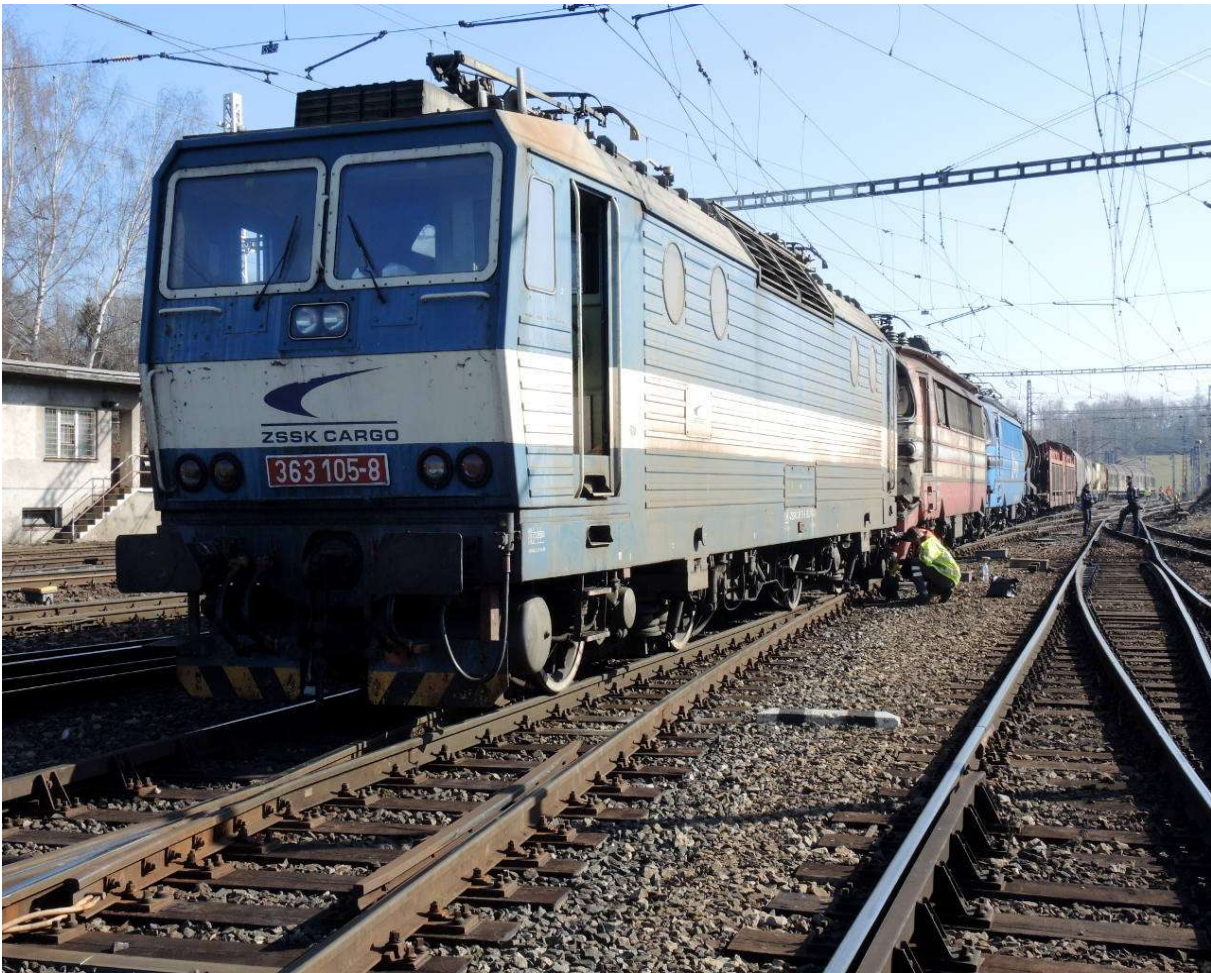
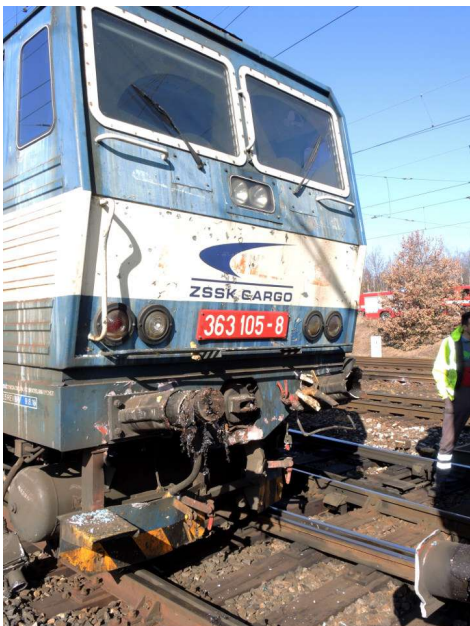
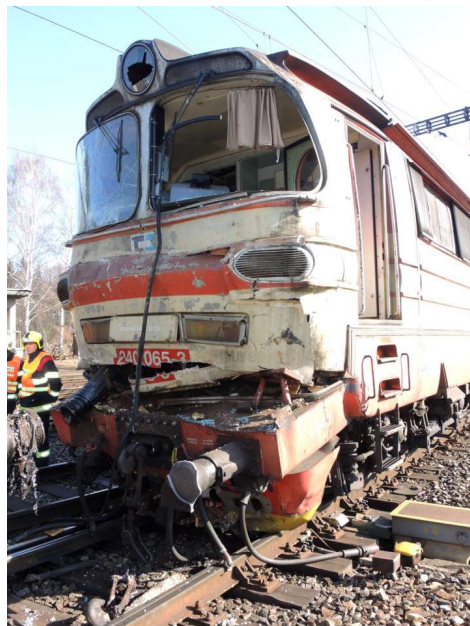
Grade:	an incident.
Date and time:	27 <sup>th</sup> February 2019, 8:38 (7:38 GMT).
Occurrence type:	train collision.
Description:	the unauthorized movement of the shunting operation behind the marshalling signal device Se7 with its consequent entry into the train route and collision with the freight train No. 45306.
Type of train:	the freight train No. 45306; the shunting operation.
Location:	Havlíčkův Brod station, the switch No. 13ab, km 223,174.
Parties:	SŽDC, s. o. (IM); ČD Cargo, a. s. (RU of the long distance freight express train No. 45306); LOKORAIL, s. s. (RU of the shunting operation).
Consequences:	0 fatality, 0 injury; total damage CZK 4 945 050,-
Direct cause:	<ul style="list-style-type: none"><li>• failure to respect the signal „Shunting forbidden” of the signal device Se7 by the train driver of the shunting operation.</li></ul>
Contributory factor:	<ul style="list-style-type: none"><li>• incorrect assessment of the radio communication content between the train driver of the shunting operation and the station dispatcher immediately before the incident, when the train driver asked through the radio station for consent to shunt, even though it has always been generally given by the light signal on the relevant signal devices for all previous shunting movements at the station perimeter;</li></ul>

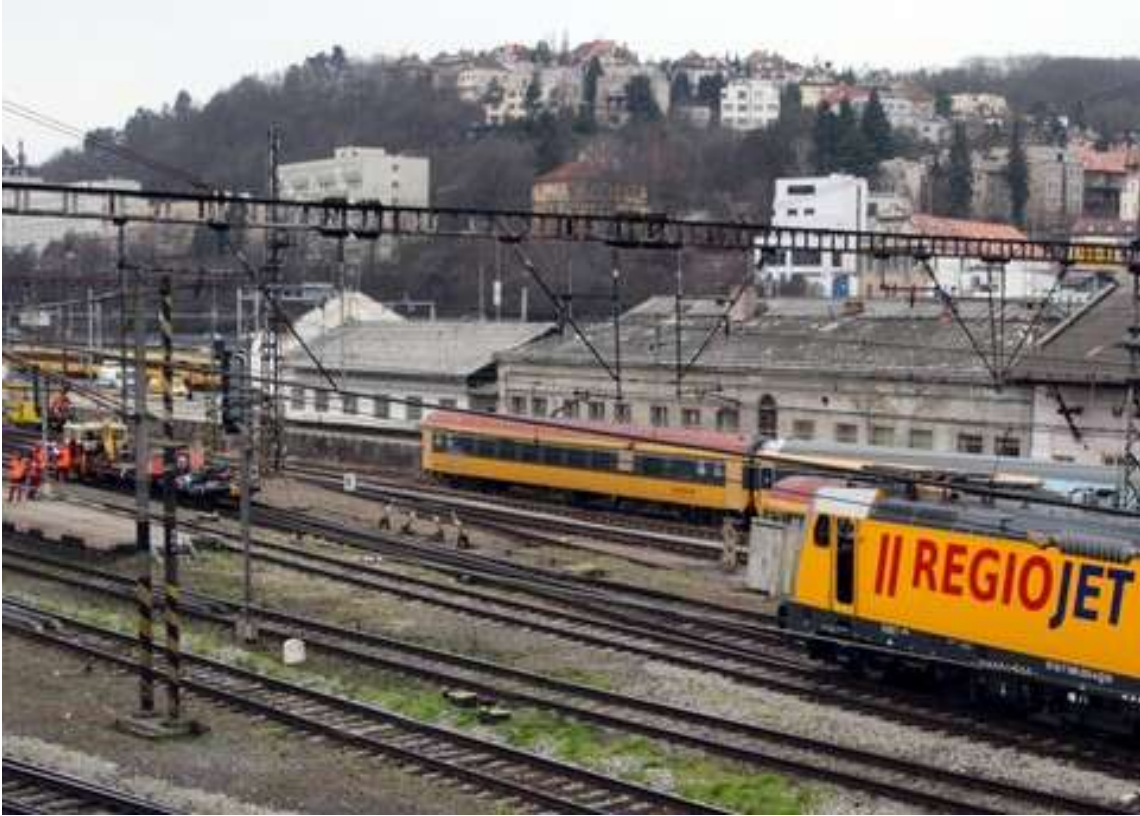
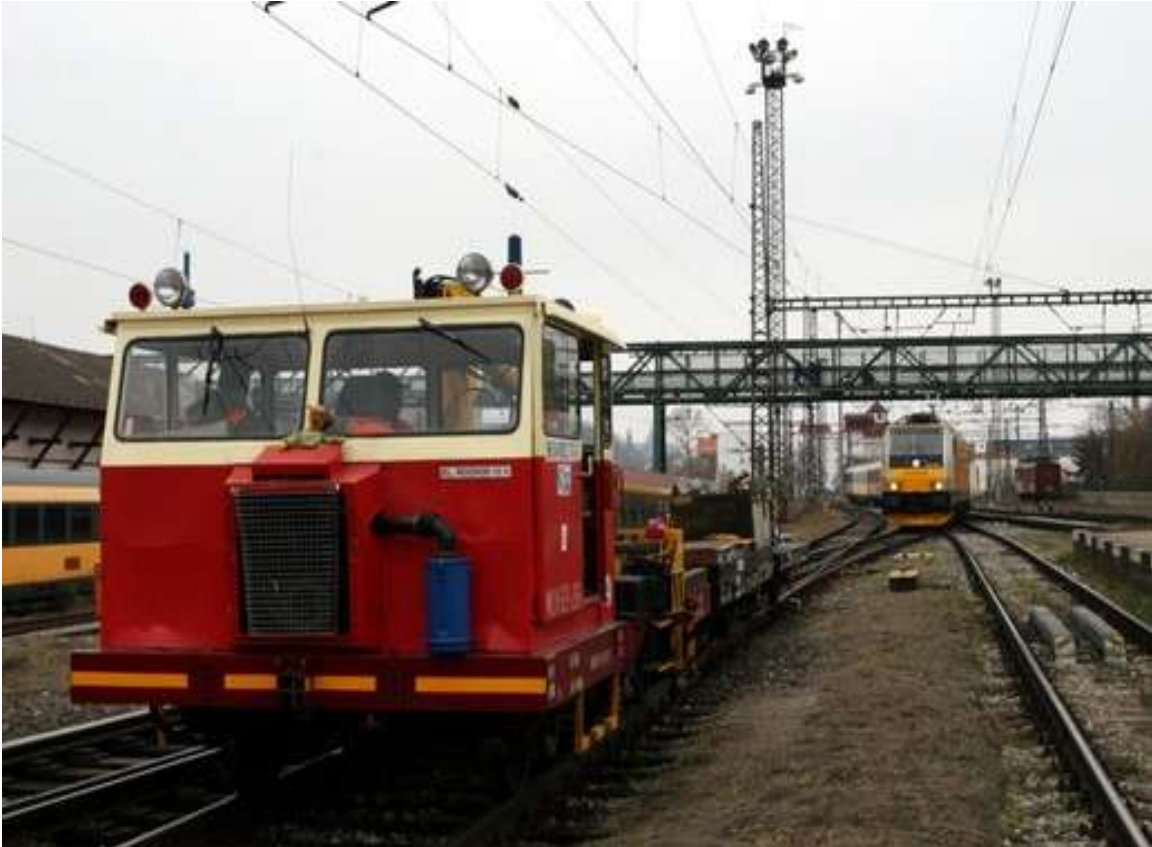
Grade:	an incident.
Date and time:	2 <sup>nd</sup> March 2019, 9:01 (8:01 GMT).
Occurrence type:	an unauthorized movement.
Description:	the unauthorized movement of the train set No. 1042 behind the entry signal device 2L with its consequent entrance into the train route of the service train No. 171181.
Type of train:	the train set No. 1042; the service train No. 171181.
Location:	Praha-Smíchov station, the entry signal device 2L, km 4,167.
Parties:	SŽDC, s. o. (IM and RU of the service train No. 171181); RegioJet, a. s. (RU of the train set No. 1042).
Consequences:	0 fatality, 0 injury; total damage CZK 0,-
Direct cause:	<ul style="list-style-type: none"><li>• failure to detect the signal Stop given by the entry signal device of Praha-Smíchov station by the train driver in training, respectively by the train driver of the train set No. 1042.</li></ul>
Contributory factor:	<ul style="list-style-type: none"><li>• absence of technical equipment which prevent a train from passing a signal in case of danger.</li></ul>

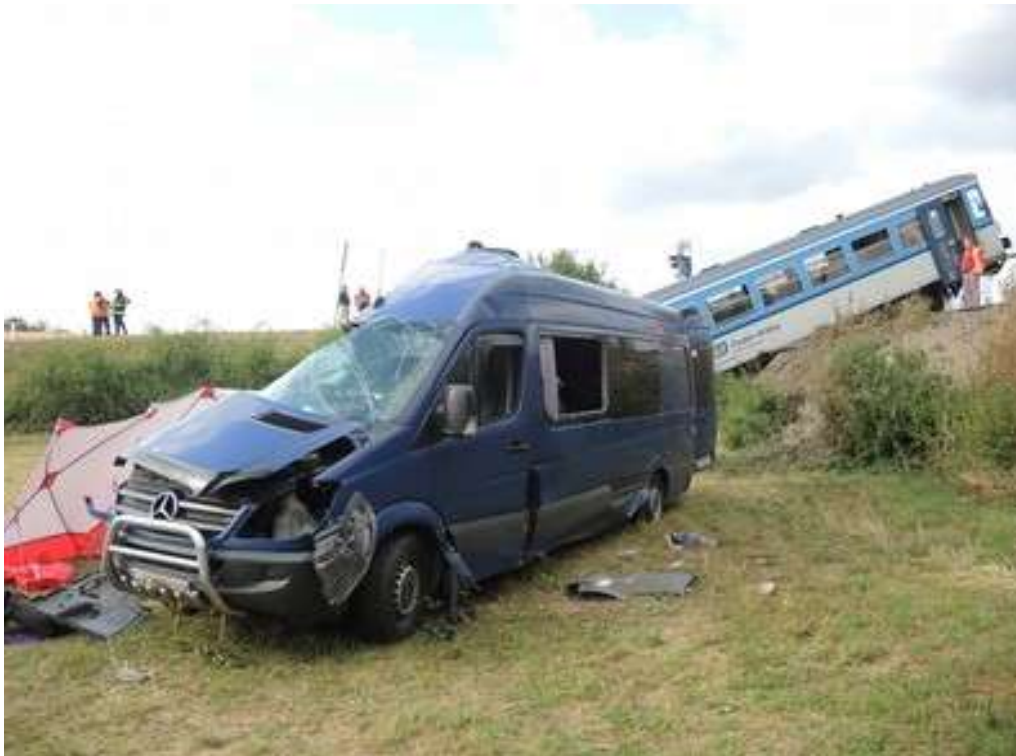
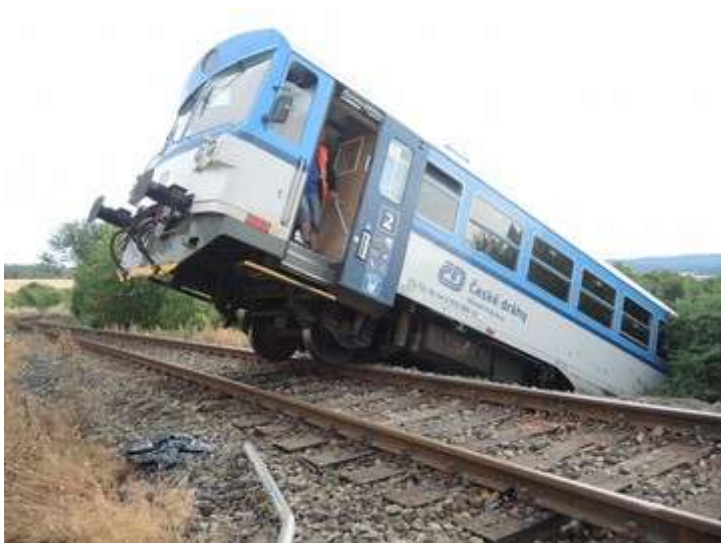
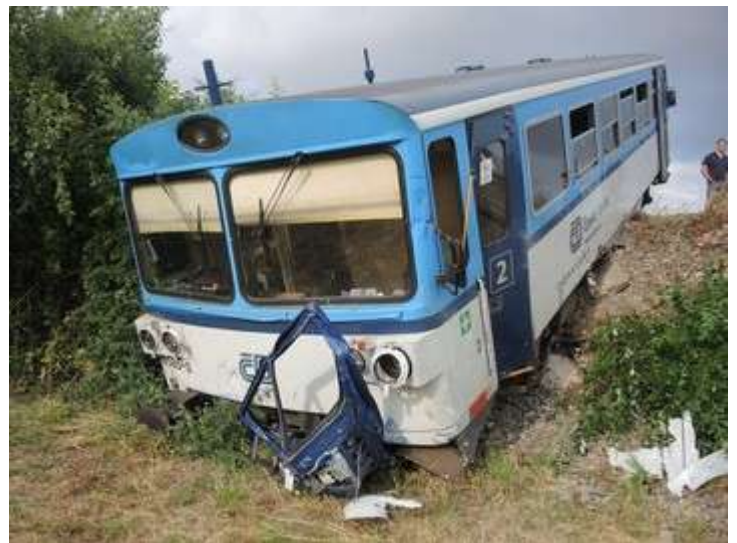
- Grade: serious accident.
- Date and time: 13<sup>th</sup> July 2019, 15:14 (13:14 GMT).
- Occurrence type: level crossing accident.
- Description: collision of the regional passenger train No. 17750 with a car at the level crossing.

- Direct cause:
- driver's failure to respect the light and acoustic warning and driving across the level crossing at the time when it was forbidden and the visual and acoustic warnings were being given.
